## 1.0 Ambrosia Lake, New Mexico, Disposal Site

### 1.1 Compliance Summary

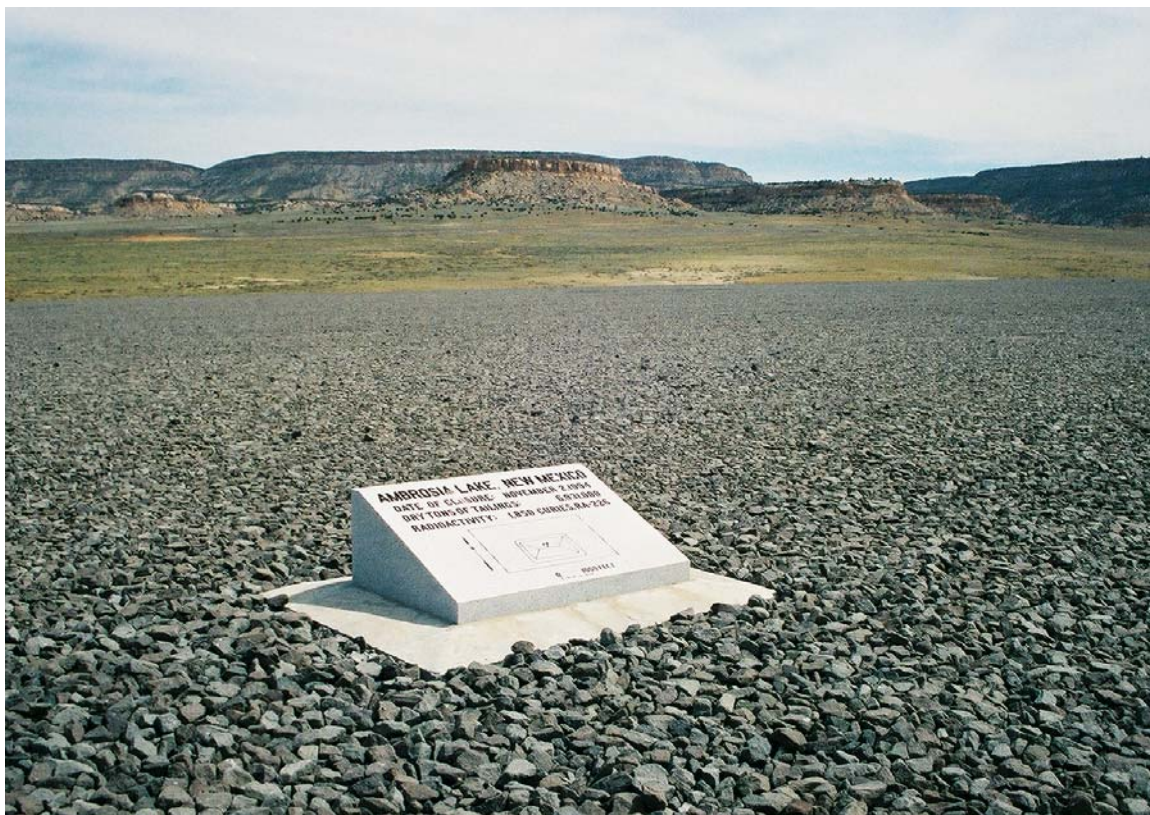
*AMB 5/2003. PL-1. Site marker SM-2 at the center of the cell cover.*

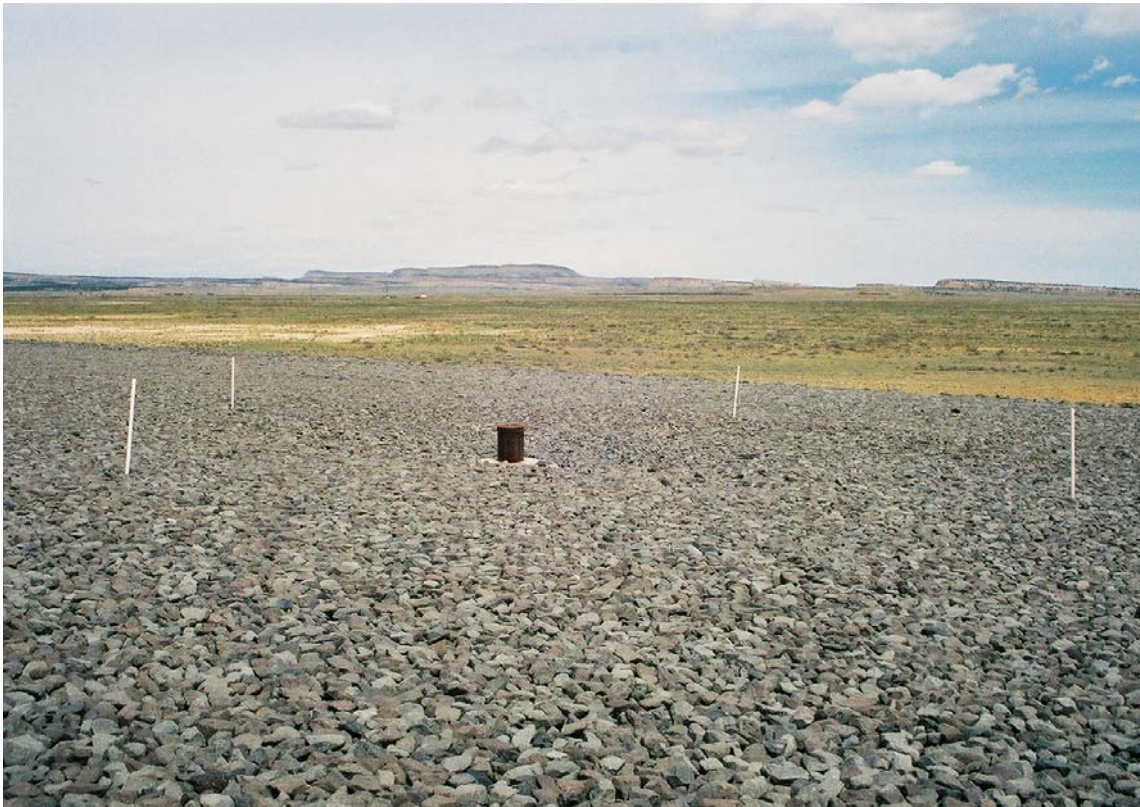
**Top of Disposal Cell**—The top of the disposal cell generally was in good condition (PL-1). With the exception of one location there was no evidence of cracking, settling, slumping, or erosion. A small shallow depression around settlement plate SP-4 was first noted during the 1997 inspection; however, there has been no evidence to suggest the depression holds water. At the time of the 2003 annual inspection, the subsidence was estimated to measure approximately 1 foot in depth (PL-2). The depression will continue to be monitored to determine if it is increasing and to ensure that the integrity and performance of the cell cover is maintained. The elevation of SP-4 and the diameter of the depression will be surveyed in 2004.

*AMB 5/2003. PL-2. Depression centered around settlement plate SP-4.*

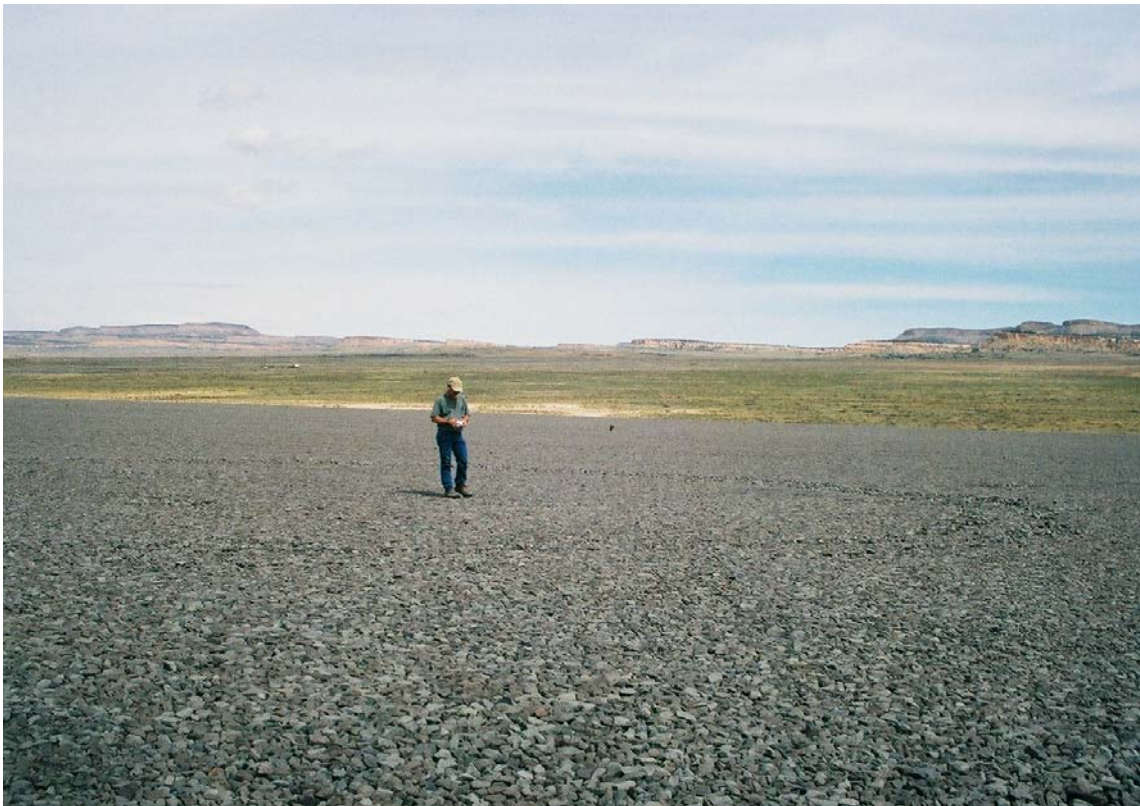
Trespassing was evident on top of the disposal cell. An all-terrain vehicle (ATV) had been driven to the top of the cell and used to mark four circles with diameters between 40 and 60 feet (PL-3). Another area of surface disturbance was noted near the southeast corner of the cell top. The tracks were very shallow and do not impair the integrity or performance of the cover.

*AMB 5/2003. PL-3. Circular-shaped vehicular disturbance on the north facet of the cell cover.*
